SATELLITE CHARGING CONTROL MATERIALS.(U)

## SATELLITE CHARGING CONTROL MATERIALS

L. LEVY, A. PAILLOUS, D. SARRAIL

FINAL REPORT FOR PERIOD MAY 1980 - DECEMBER 1980.

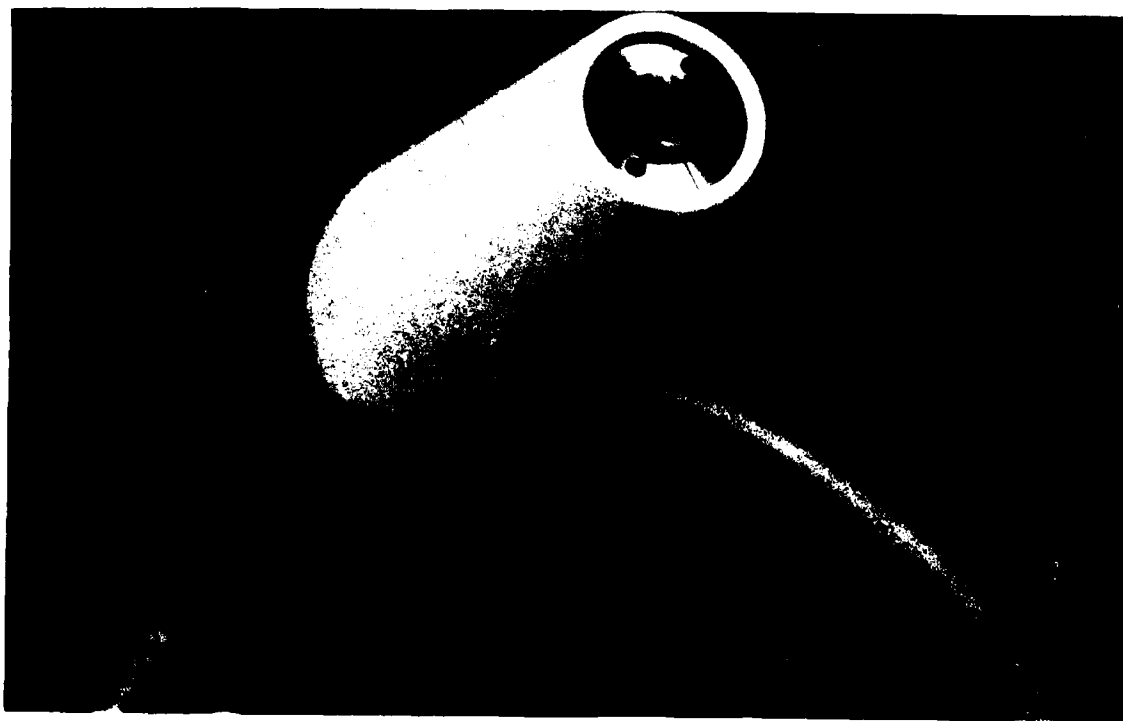
PHOTOGRAPH C3 View showing the copper hot end and the adjustable spring spanner.

The tool is a Weller WECF-Temtronik soldering station with the iron modified (Fig. C1). Photograph C1 shows the tool in the stowed position and in Photograph C2 the hand grip and hot end can be seen. Photograph C3 shows the heated face in detail
